Final  
Technical Summary Report  
of  
RESEARCH AND DEVELOPMENT PROGRAM  
OF  
THERMIONIC CONVERSION OF HEAT TO ELECTRICITY

Volume I

June 30, 1964

GENERAL ELECTRIC COMPANY  
SPECIAL PURPOSE NUCLEAR SYSTEMS OPERATION  
VALLECITOS ATOMIC LABORATORY  
P. O. BOX 846  
PLEASANTON, CALIFORNIA

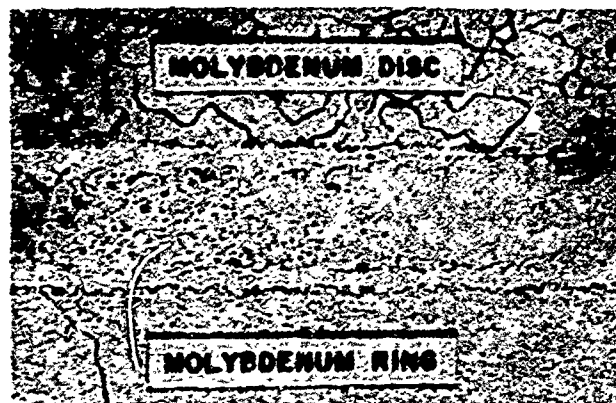
Figure III-21

1600°C, 95 Hours, Dry H<sub>2</sub>  
Leaker

250X

Diffusion Bond to Mo to Mo Using Chromium Plating  
to Promote Diffusion

Others<sup>32</sup> have tried similar approaches to form graded seals. However, solid-state (rather than liquid-metal) diffusion was used with chromium, (instead of nickel) as the active diffusing metal. With solid-state diffusion, the diffusion rates are inherently lower and therefore bonding to the metallizing required heating to  $1800^{\circ}\text{C}$  and holding for one hour. Besides requiring a very high bonding temperature, this system has the disadvantage of requiring the mating pieces to be quite smooth and parallel, whereas with braze diffusion bonding the liquid can, to a certain extent, move around and increase contact.

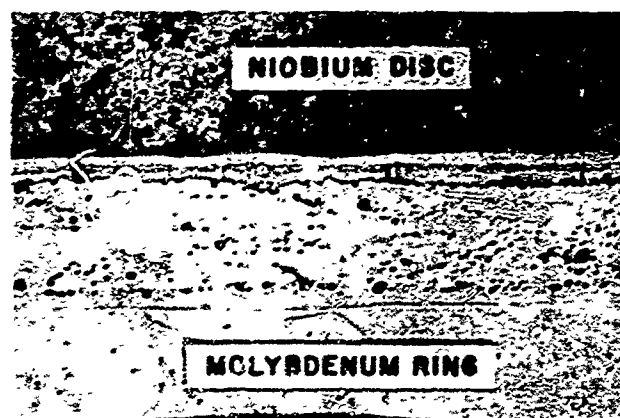
Braze: G-E J8400  
1220°C, 1 Min, Vacuum

Leaker

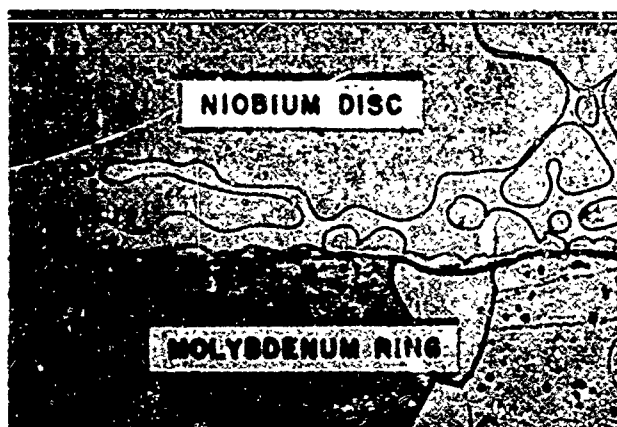
5 CNM 1400°C, 10 min, 0.0005 in. Ni  
Vacuum Tight

250X

Nickel braze diffusion bonding of niobium discs, either to molybdenum rings or metallized A-976 ceramic rings, was also quite successful. However, the resulting structures are not as ideal as those obtained with molybdenum discs. While complete bonding between the niobium and molybdenum was developed, isolated islands of a Nb-Ni intermetallic phase were never completely eliminated. The variation in the distribution of this phase with hold time and nickel shim thickness is illustrated in Figure III-23. Holding at  $1400^{\circ}\text{C}$  for 10 minutes with a 0.0005-inch nickel shim (5 CNM) produces a structure approaching that obtained when holding at  $1400^{\circ}\text{C}$  for 2 minutes with a 0.0001-inch nickel shim (8 CNM). When using a 0.0005-inch nickel shim and only holding for 2 minutes at  $1400^{\circ}\text{C}$  (7 CNM) the Nb-Ni intermetallic phase forms in a continuous band across the seal. This band is very brittle and can easily result in a leak path if thermal stresses cause it to fracture (as apparently was the case with specimen 7 CNM). The as-brazed structure of specimen 1 CNA, which was brazed at about  $1200^{\circ}\text{C}$  for 10 minutes using a 0.0005-inch nickel shim, is shown in Figure III-42 (page III-129). This figure shows that at  $1200^{\circ}\text{C}$  the braze does not penetrate the niobium, but a continuous band of brittle phase, as illustrated by the cracks, is formed. It is interesting to note that holding this joint

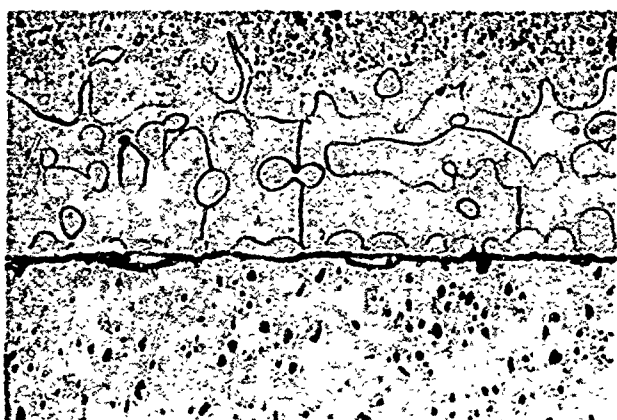
7 CNM 1415°C, 2 min, 0.0005 in. Ni  
Leaker

250X

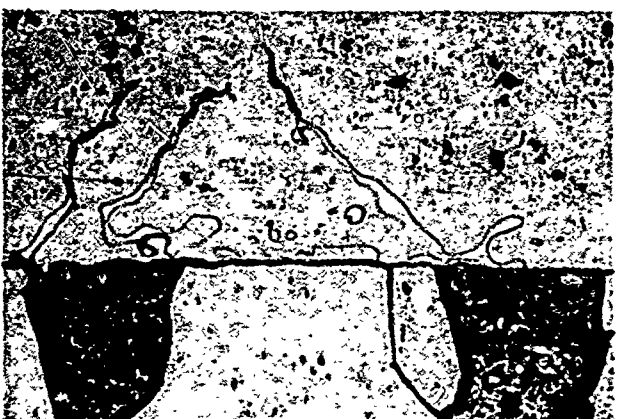
8 CNM 1415°C, 2 min, 0.0001 in. Ni  
Vacuum Tight

250X

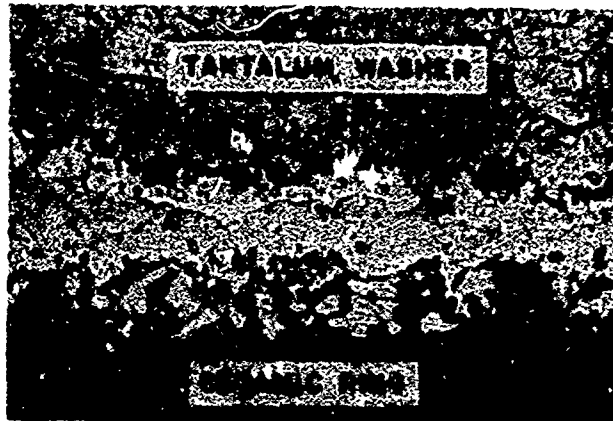
Figure III-24

8 TNA brazed  $1500^{\circ}\text{C}$ , 5 min, .0001 in. Ni (500X)

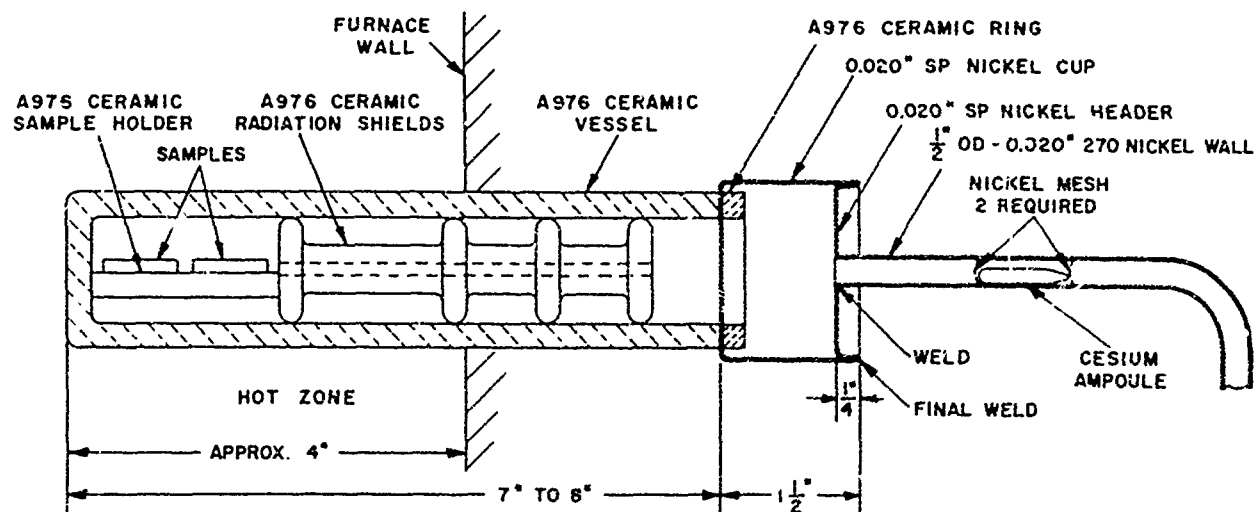
Cesium corrosion resistance of various materials and seals was determined at  $1000^{\circ}\text{C}$  and 20 Torr cesium pressure. The test vessels were made of high purity alumina (G-E A-976) ceramic, while the end closure and cesium reservoir were made from high purity nickel.

Figure III -25  
Schematic Cross-Section of Ceramic Test Vessel

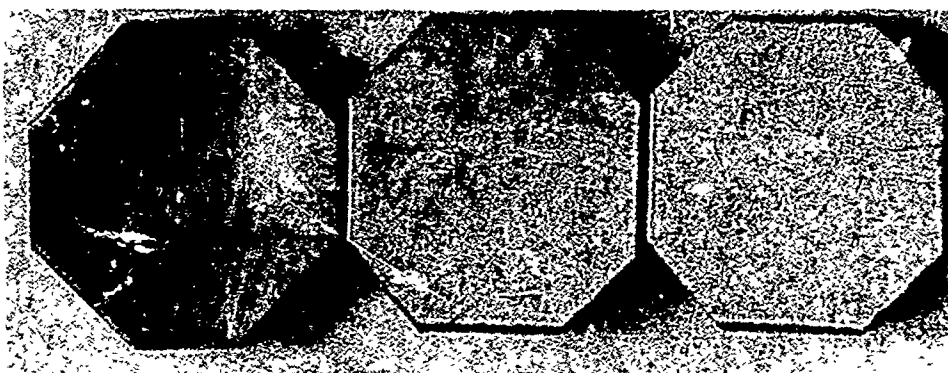
Appearance (approx. 2X)

Before	After Specimen 3	After Specimen 4	
Weight:		1.5318 g	1.5391 g	Before
		1.5320 g	1.5395 g	After

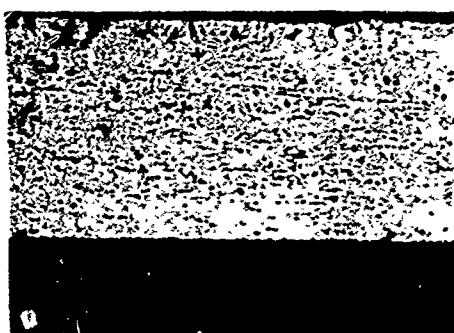
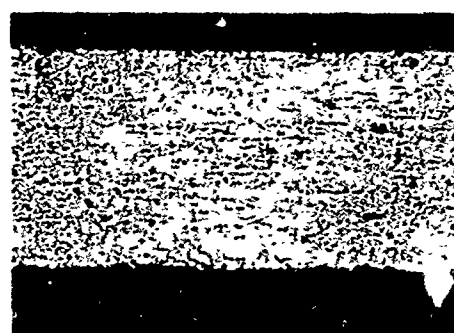
Microstructure (100X)

Before

After  
Specimen 3

Etch: 50 ml  $H_2SO_4$   
20 ml  $HNO_3$   
20 ml HF

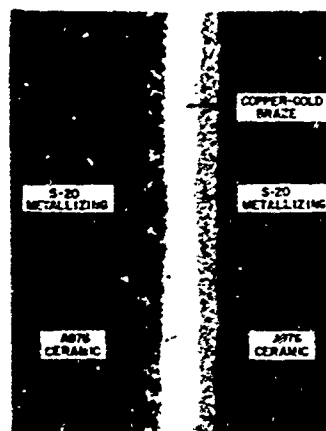
Microstructure (100X)

Unetched

After

Before

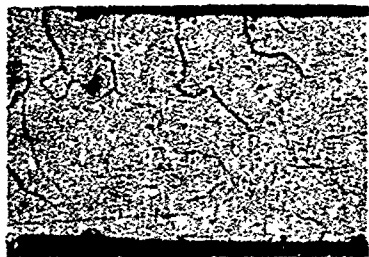
Before	After Specimen 1	After Specimen 2	
Weight:		0.7627 g	0.7691 g	Before
		0.7621 g	0.7686 g	After

Remarks. Specimens had rough surface after testing and were covered with thin white film. Microstructure indicates that roughness was due to shifting of grains during growth realized during testing.

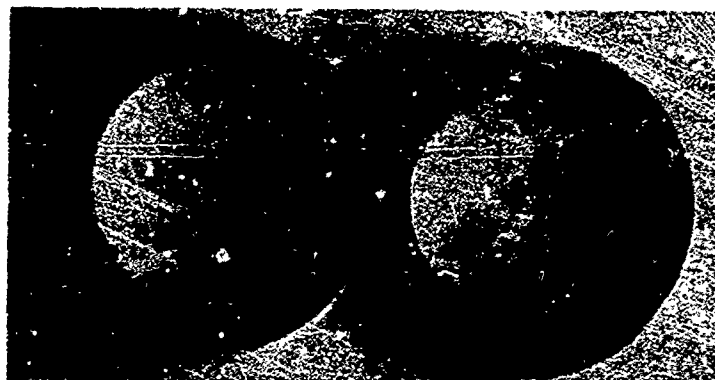
Appearance (approx. 2X)

Before

After

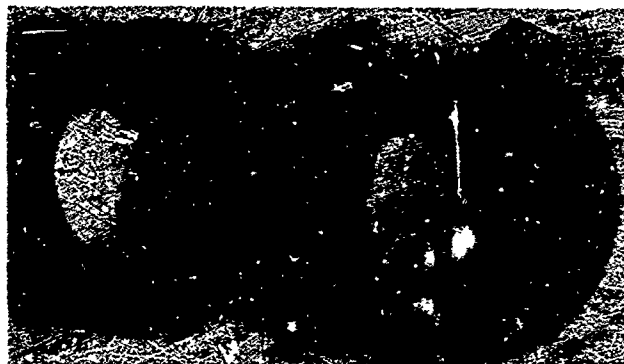
Appearance (2X)

Before

After

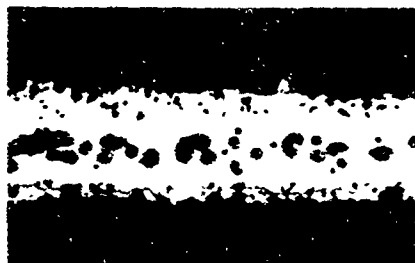
Microstructure (250X)

After

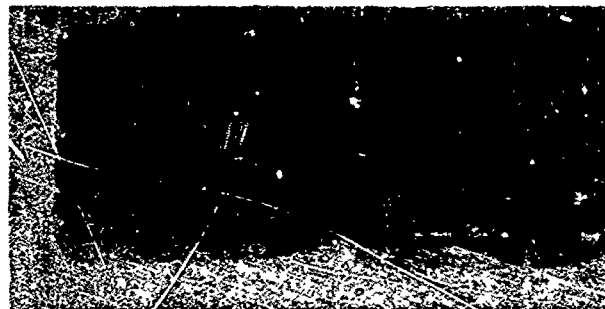
Appearance (2X)

Test Conditions: 1000°C, 20 Torr cesium pressure

After  
Specimen 3  
7.5629 g  
7.5615 g

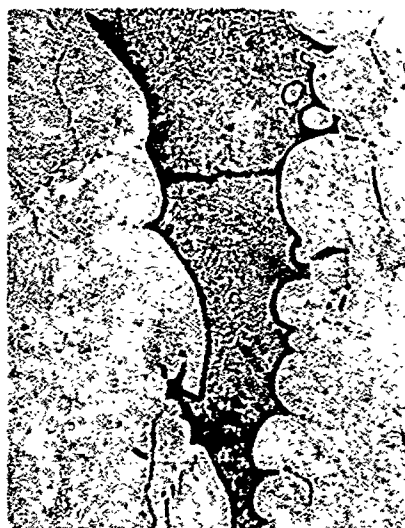
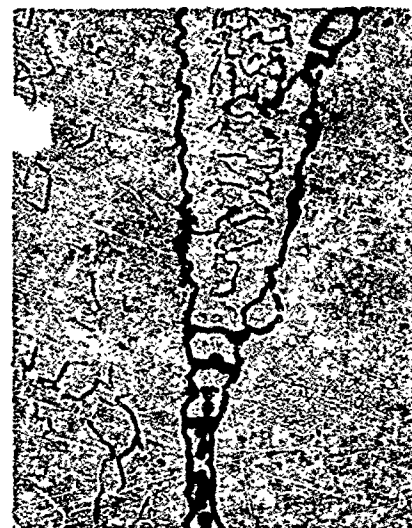
Microstructure (250X)

Molybderum-to-Molybdenum

Before (No. 6 MNM)

After (No. 2 MNM)

Remarks: No apparent attack of either specimen. Specimen No. 5 TNM still leak tight after testing, No. 2 MNM leaked. Note coarsening of braze structure in No. 2 MNM.

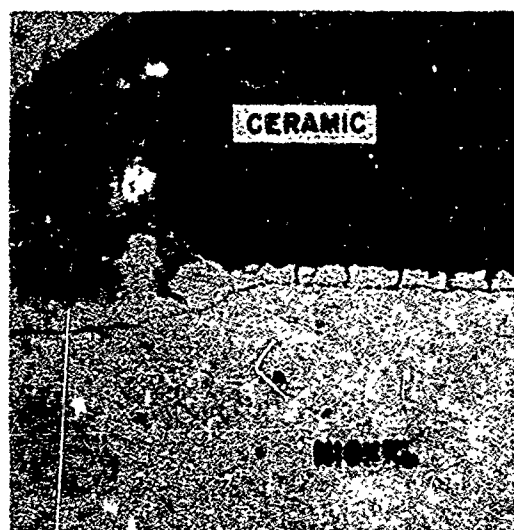
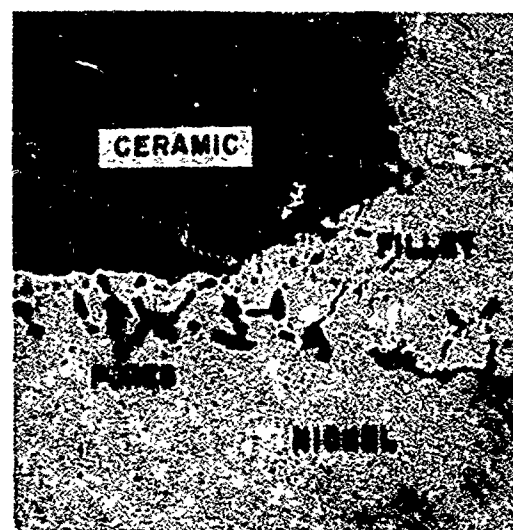
Microstructure (250X)

Etch: 4-1/2 H<sub>2</sub>O 4-1/2 HNO<sub>3</sub>, 1 HF, 9 Lactic

Specimen B86B Before

Specimen B86B After

Remarks: Pores formed and bonds lost in all specimens from continued diffusion of titanium into nickel. Intermetallics in fillet still bonded to ceramic. As tested microstructures of other specimens looked similar to that shown. No attack by cesium was noted on any of the specimens.

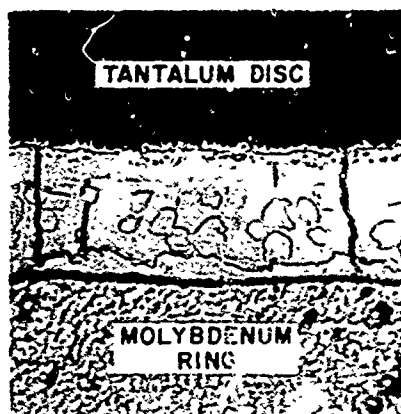
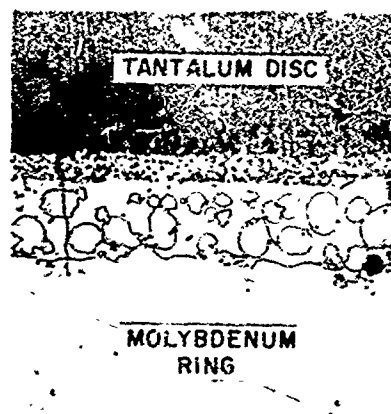
Etch: 50 H<sub>2</sub>SO<sub>4</sub>, 20 HNO<sub>3</sub>, 20 HF

6 TNM brazed approximately 1450°C, 10 min., 0.0005-inch nickel shim

Remarks: No apparent attack. Note widening of phase adjacent to tantalum in lower temperature brazed specimen from corrosion testing.  
Pores in 7 TNM due to unbalanced diffusion during brazing

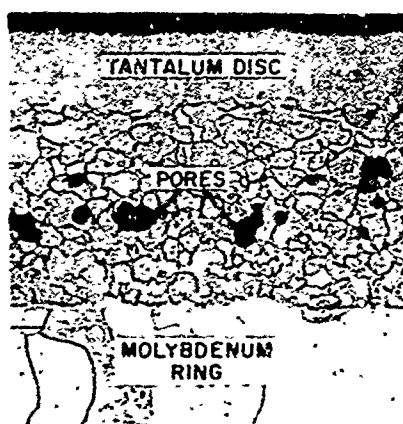
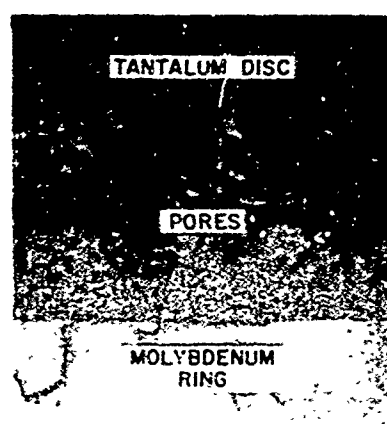
7 TNM brazed approximately 1480°C, 15 min., 0.0005-inch nickel shim

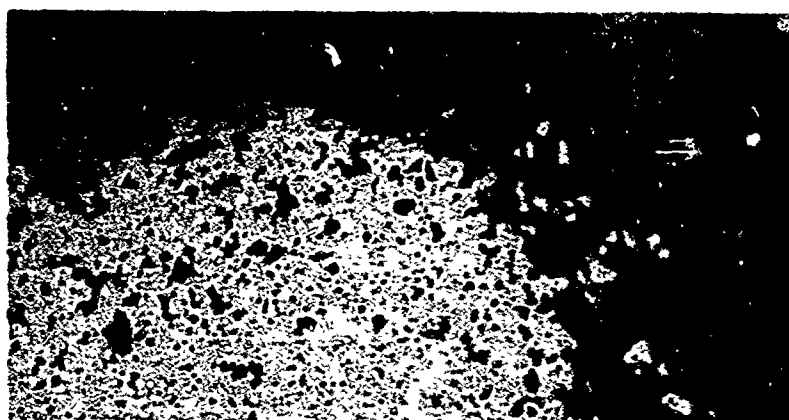
Microstructure (100X)

Metallized Surface

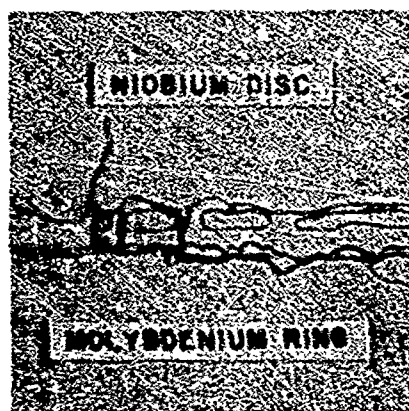
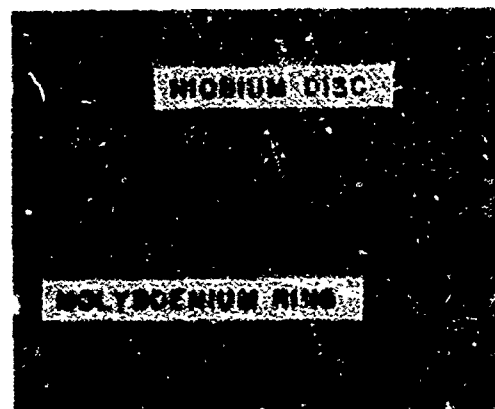
Before (250X) After  
2 CNM brazed approx. 1300°C, 2 min., .0005-inch nickel shim

Before After  
1 CNA brazed approx. 1200°C, 10 min., .0005-inch nickel shim

Remarks: No apparent attack. Note change in microstructures due to the prolonged holding at the test temperature.

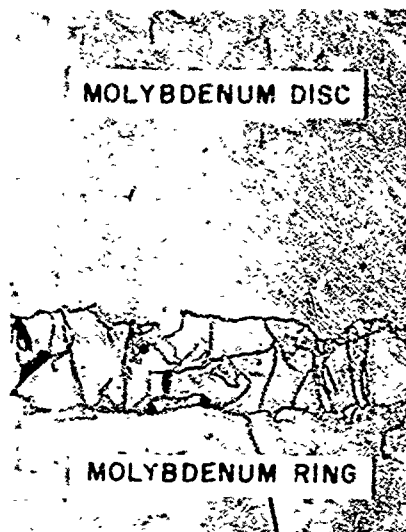
1M60M - brazed 1120°C, 1 min.,  
Nicrobraz 60

Remarks: No apparent attack. Note formation of very brittle (cracked) intermetallic compounds from testing. Specimen brazed with Standard Nicrobraz similar to 1M60M and specimen brazed with Nicrobraz 150 similar to 1M84M after testing.

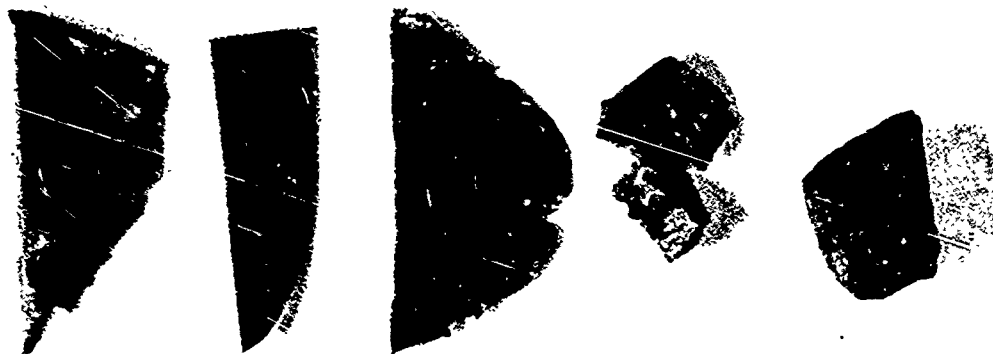
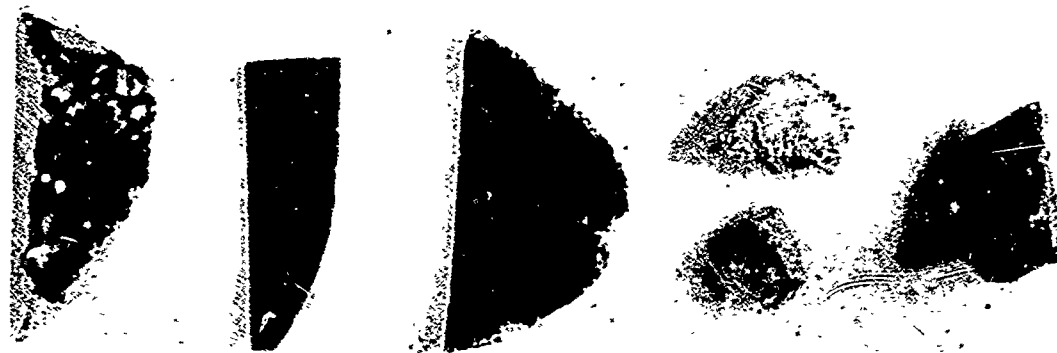
Appearance (2X)

Test Conditions: 1000°C, 20 Torr cesium pressure  
Hours Tested: 500

AS 501	514	540	546	547
Weight:	0.5193 g	0.2323 g	0.5535 g	0.8200 g	1.5055 g Before
	0.5224 g	0.2325 g	0.5539 g	0.8201 g	1.5056 g After

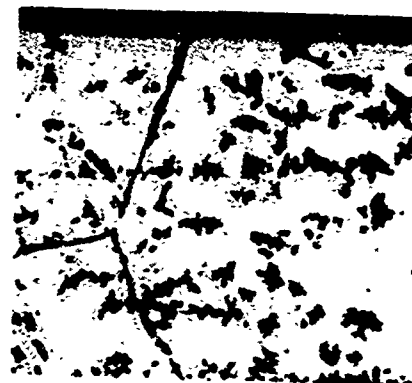
Remarks: AS 501 reacted with pallet, no Cs attack, recrystallized -  $\alpha$  Ti precipitated on cooling. AS 514 no attack - recrystallized. AS 540 no attack - recrystallized. AS 546 no attack - possibly some solutioning of network phase. AS 547 no attack - no apparent change in structure.

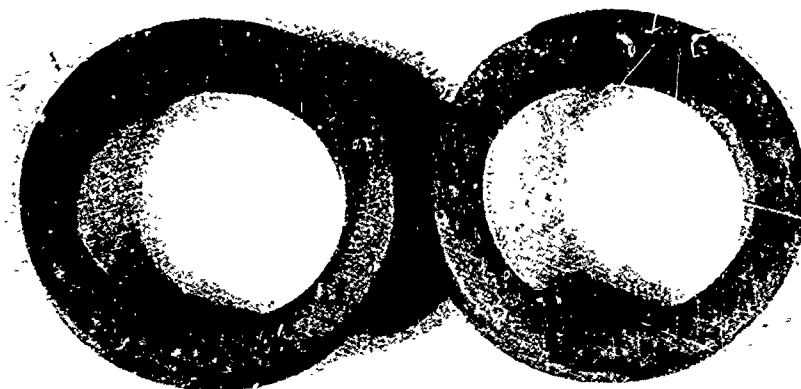
Appearance (approx. 2X)

Test Conditions:  $1000^\circ\text{C}$ , 20 Torr cesium pressure

Remarks: Specimens turned from metallic gray to bluish gray from testing.  
Sweating of specimens after testing indicated bleeding of cesium.  
Note apparent increase in porosity of microstructure from testing.

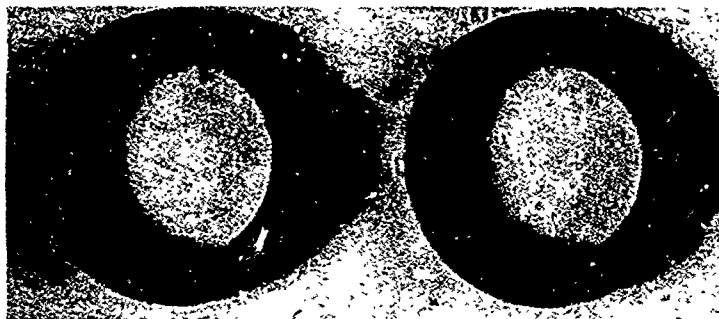
Appearance (approx. 2X) Coors AD995

See Test No. 14 for  
appearance of H-1  
metallizing on A-976

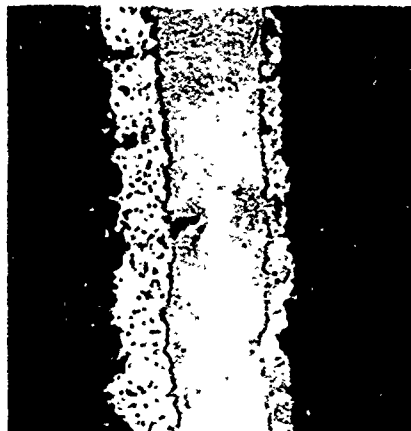
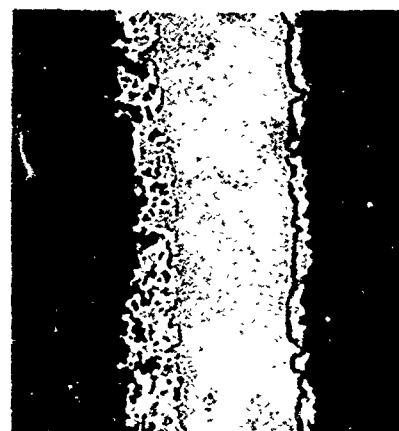
Microstructure (250X)

After Coors AD995

After A-976

Remarks: No attack of either ceramic or of H-1 metallizing on either ceramic. Specimens brazed together with Cu-Au before sectioning. Double coating of metallizing on ceramics on left, single on right.

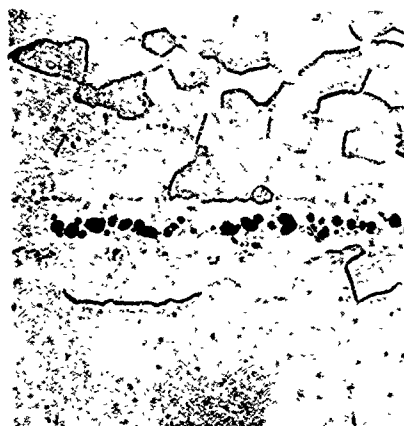
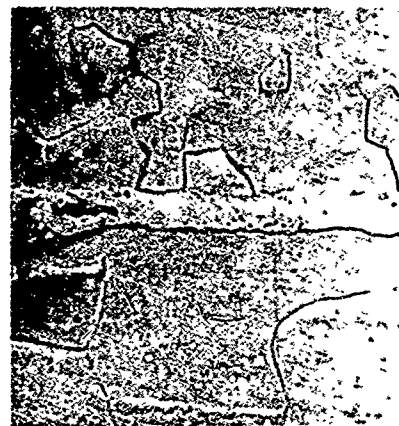
Mo Disc

Mo Ring

Before  
Specimen 5 Pd

After  
Specimen 4 Pd

Remarks: No signs of attack on cermet or Pd diffusion bond. Both specimens still leak tight. Cermet discussed under Multilayered Cermets section of this report. Pores due to faster diffusion of Pd into Mo than Mo into Pd.
